ROCK ISLAND LAKE DAM

JOHNSON COUNTY, MISSOURI

MO 20182

PHASE 1 INSPECTION REPORT NATIONAL DAM SAFETY INSPECTION

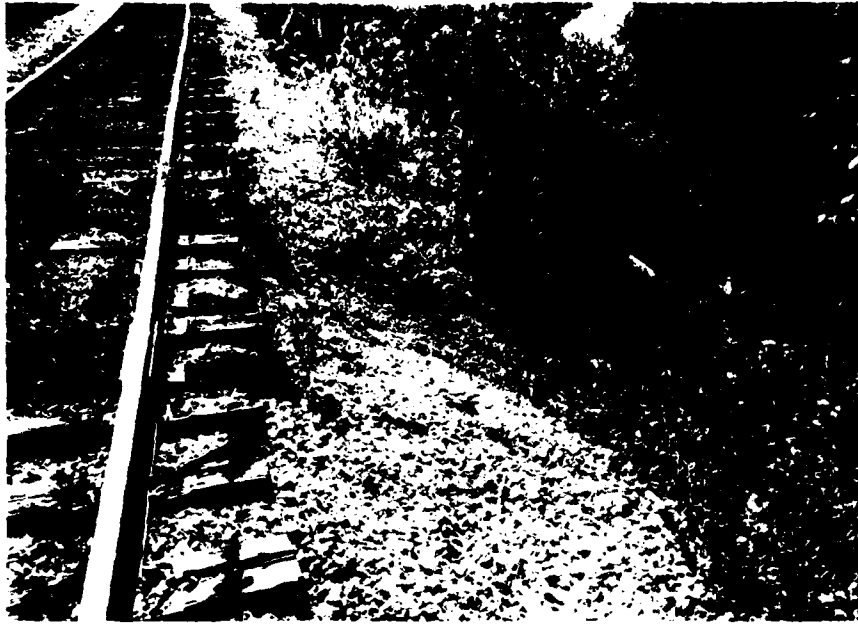
PHOTO 11: EMBANKMENT EROSION OF DOWNSTREAM FACE AT SPILLWAY

(3) The erosion on the embankment slopes should be repaired and proper slope protection reestablished so that further loss of embankment material is prevented.

(3) The erosion on the embankment slopes should be repaired and proper slope protection restored.
